**Humboldt Bay Municipal Water District
and
Ruth Lake Community Services District**

Prevention Plan for Quagga and Zebra Mussels at Ruth Lake

Updated April 2019

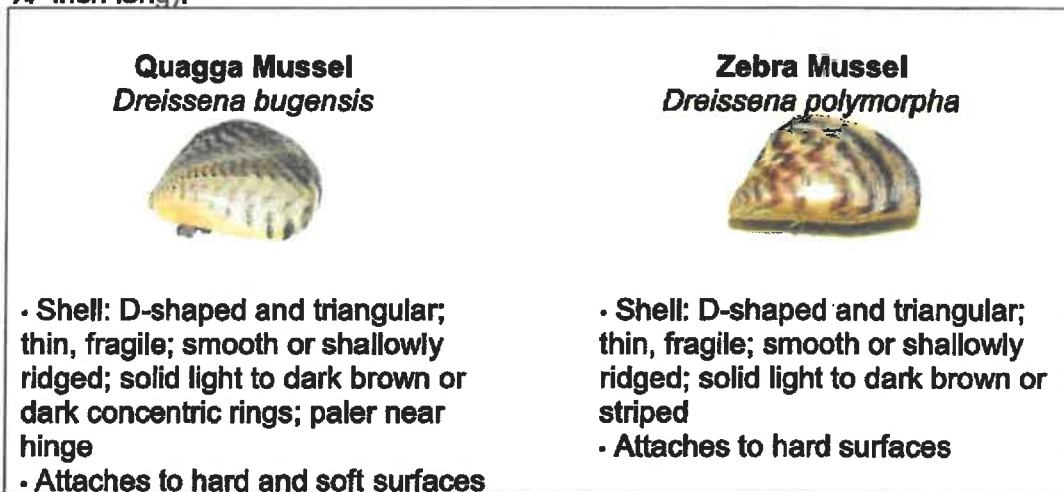
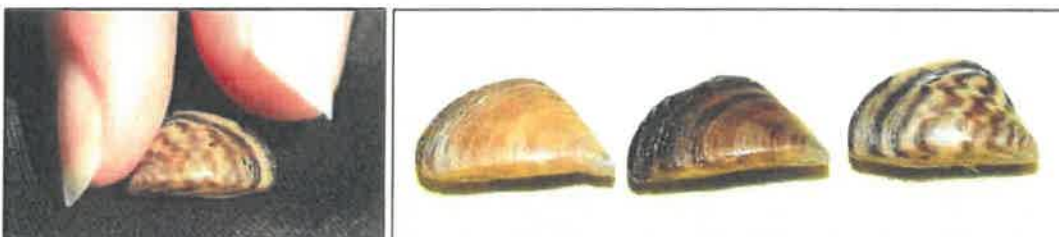
The quagga mussel, *Dreissena rostriformis bugensis*, and the zebra mussel, *Dreissena polymorpha*, are small mussels found only in freshwater. They look very similar to each other. They commonly have alternating light and dark brown stripes, but can also be solid light brown or dark brown. They have 2 smooth shells that are shaped a little bit like the letter "D". These mussels are usually less than 2 inches in length. In new populations, most mussels are young and therefore very small (under ¼ -inch long).

Color variation in quagga and zebra mussels

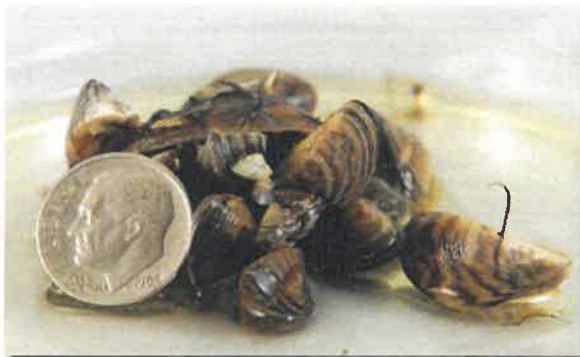
Zebra mussels next to dime.

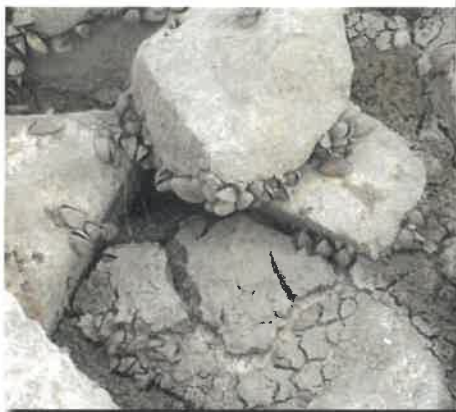
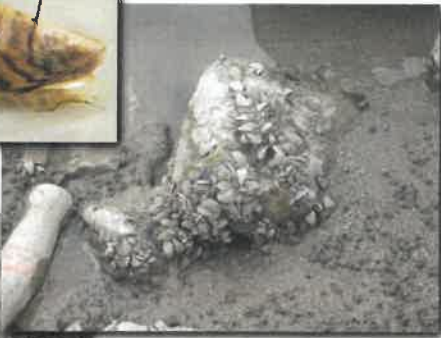
Zebra mussels at San Justo Reservoir (right/below)

Various sizes of Quagga/Zebra mussels.

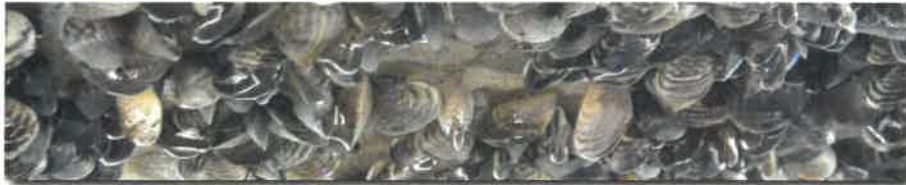
Quagga mussels on boat hull found at California Border Protection Station.

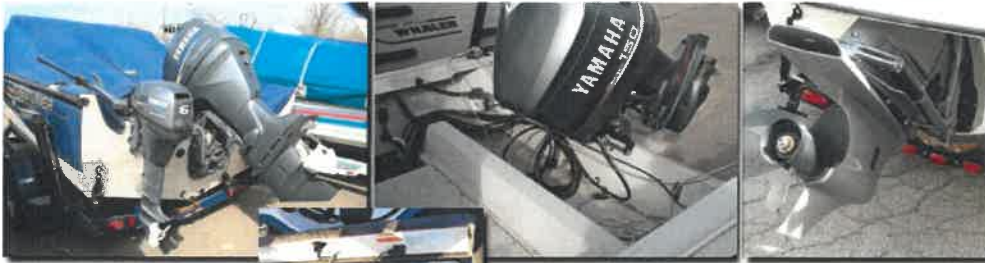
Drain the engine, dry the motor well, check the prop and system components, clean trolling motors, make sure everything is drained and dried. Remove all aquatic weeds.

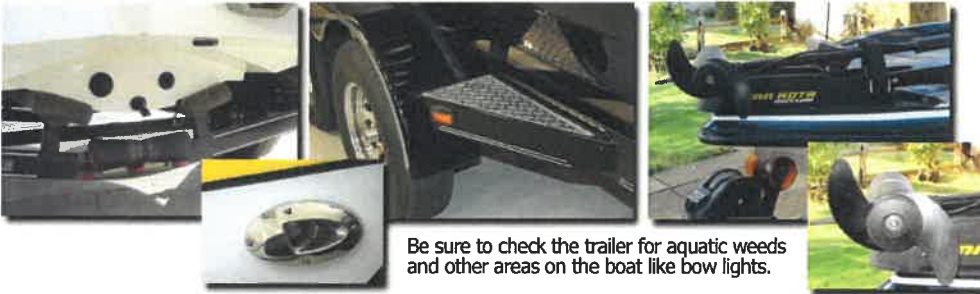
Be sure to check the trailer for aquatic weeds and other areas on the boat like bow lights.

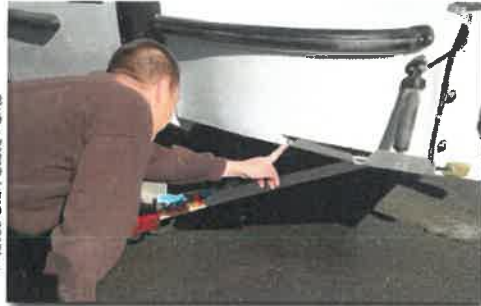
Check all areas listed under general inspection and cleaning. Feel the hull and check the trim tabs to ensure no standing water (veligers) or adults have taken hold. Check for weeds and other material as well.

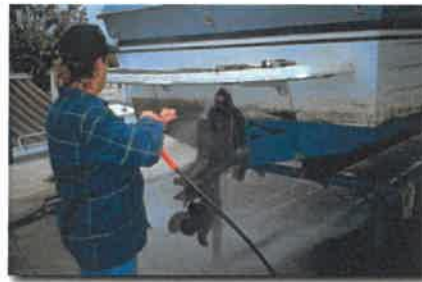
Check, clean, drain and dry live wells, all drains, and any other area where water might collect.

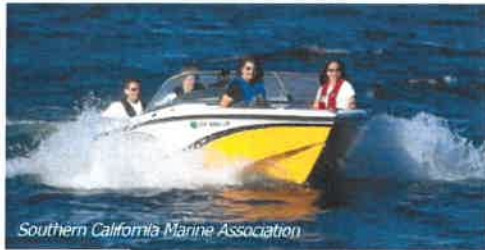
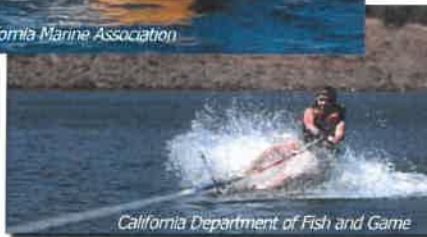
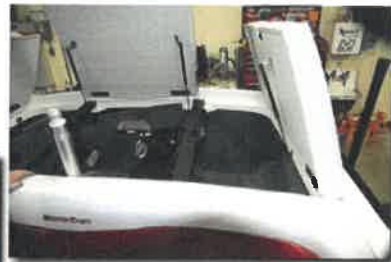
Ski boat covers open.

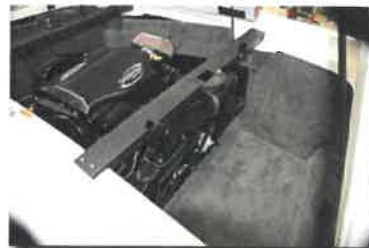
Ski boat ballast water lines.

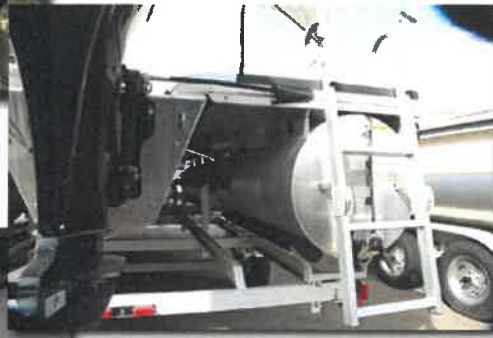
All areas that can hold water should be drained and dried. Pontoons should be inspected for mussels, settlers, and aquatic weeds that may have mussels attached.

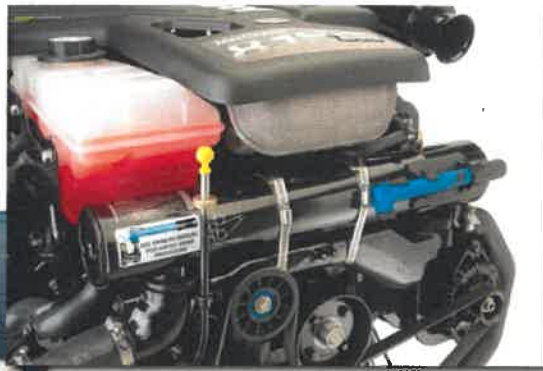
Closed cooling system.

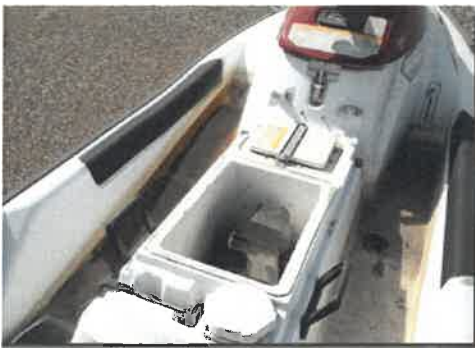
Personal watercraft should be drained of all water, washed, and dried.

The steering nozzle should be inspected for aquatic weeds that might have mussels.

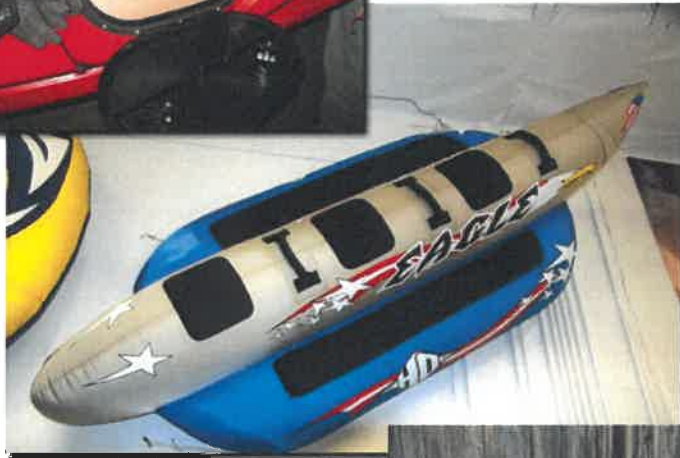
Kayaks, canoes and all inflatables need to be cleaned, drained, and dried.

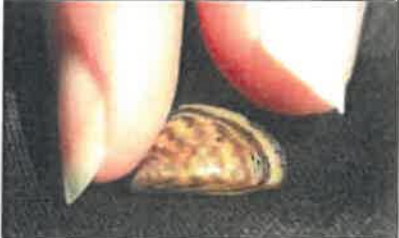
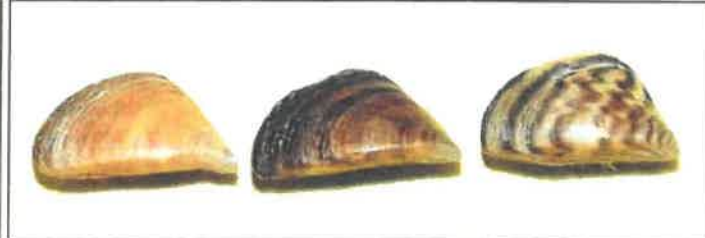
<ul style="list-style-type: none"> • Shell: D-shaped and triangular; thin, fragile; smooth or shallowly ridged; solid light to dark brown or dark concentric rings; paler near hinge • Attaches to hard and soft surfaces 	<ul style="list-style-type: none"> • Shell: D-shaped and triangular; thin, fragile; smooth or shallowly ridged; solid light to dark brown or striped • Attaches to hard surfaces

Color variation in quagga and zebra mussels

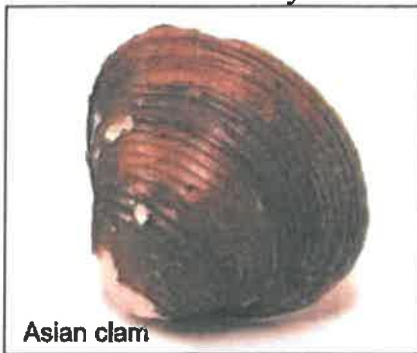
Asian clam, *Corbiculafluminea*

People often mistake the very common Asian clam (also introduced) for quagga or zebra mussels. The Asian clam is widespread and abundant in California. It is brown and has ridges in concentric rings on its shells. The shells of older clams or of dead clams are white at the hinge (where the two shells join together). These clams do not attach onto surfaces. They live in mud or sand.

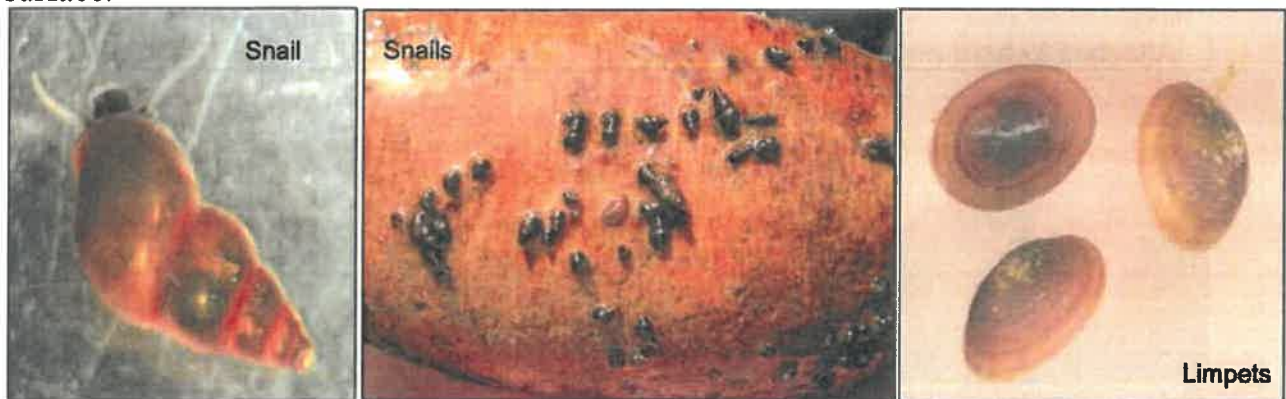
Snails and Freshwater Limpets

Small snails and freshwater limpets cling to hard substrates and can be mistaken for small juvenile mussels. They are similar in color and size to small quagga and zebra mussels. Snails have a spiral shape. Limpets have one shell and are flat. Quagga and zebra mussels attach on the edge of their shell and stick up and away from the surface.

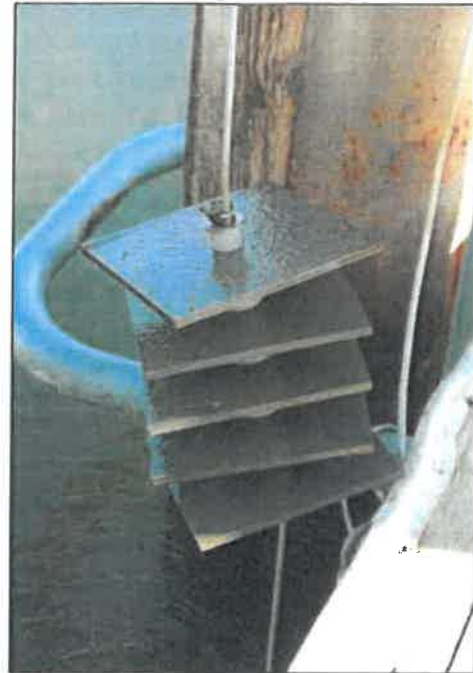
Example of a label

California Department of Fish and Wildlife
Biological Research
PLEASE DO NOT DISTURB
For information about this study please contact:
Bob Smith, Environmental Scientist xxx-
XXXX
